PROJECT PROFILE

Aerial Assessment of Riparian Areas of the Vermilion River and its Major Tributaries

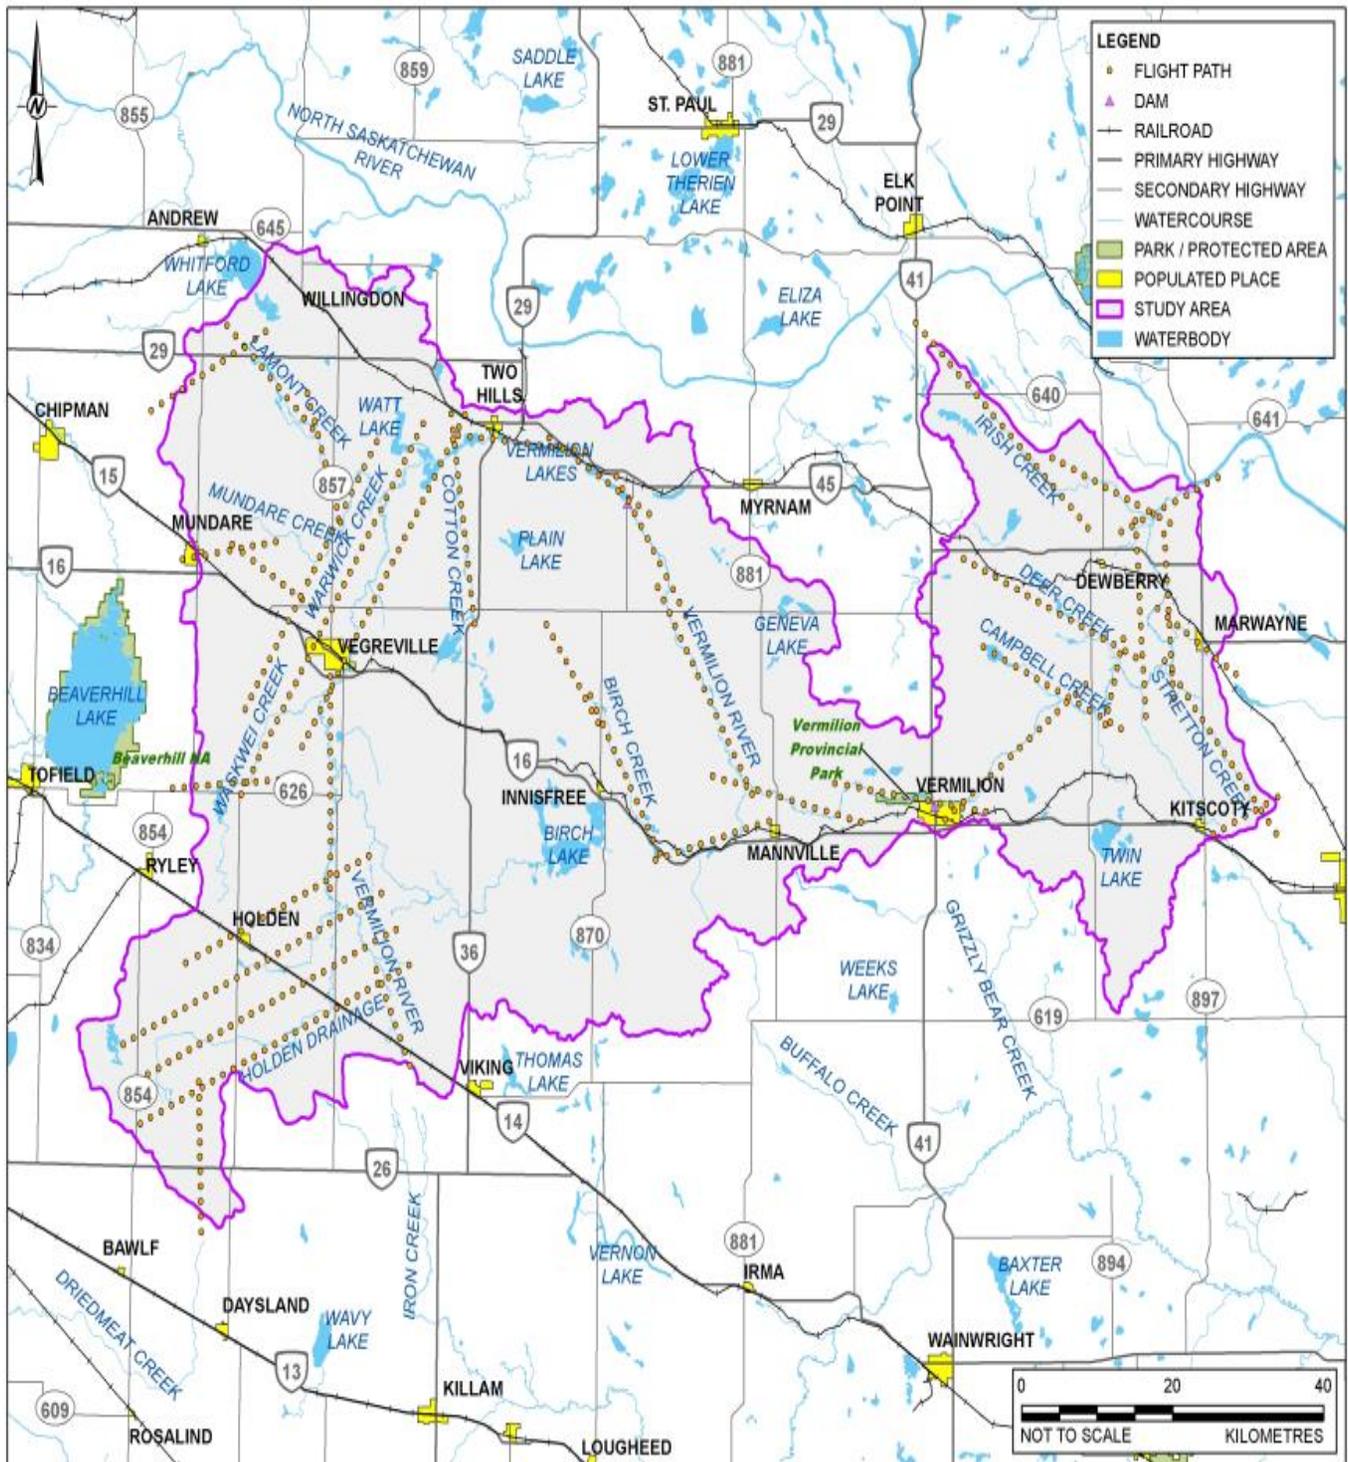
Figure 1: Flight Plan for Collection of Imagery

Golder contracted Tarin Resource Services Ltd. (Tarin) from Calgary, Alberta to acquire digital stereo imagery and LiDAR data for the Vermilion River and identified tributaries. Digital, colour imagery was acquired on August 23rd and September 12th, 2015 for a 1 kilometer (km) wide corridor, centered on the following watercourses (Figure 1):

Vermilion River	Birch Creek	Campbell Creek	Cotton Creek
Deer Creek	Mundare Creek	Irish Creek	Marwayne Creek
Stretton Creek	Waskwei Creek	Holden Drainage	Holden Creek
Lamont North Creek	Warwick Creek
